**Data Structure Report of Archaeological Works
(Stage 1) at Burgh Halls, Linlithgow**

Client: West Lothian Council

August 2007

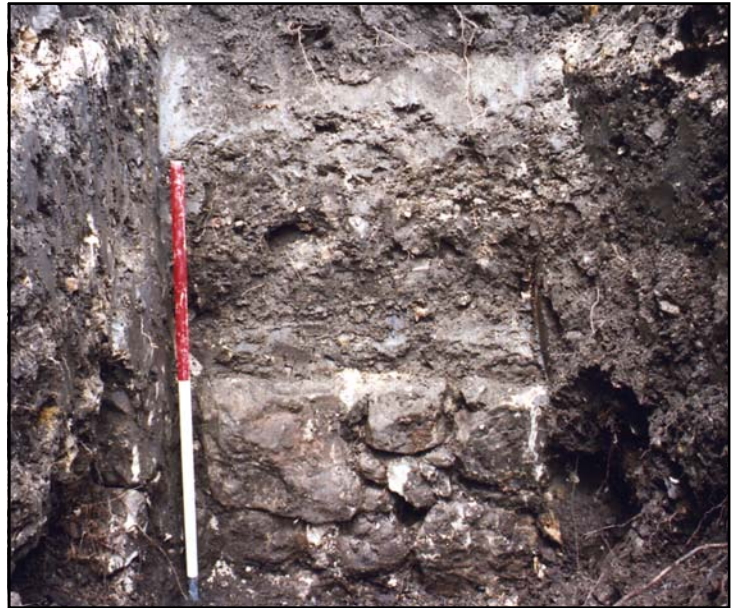
Fig. 3 - South face of wall 07 in Trench 1, sondage 3

Wall [07; Figure 3 & 4] ran east/west across the trench. It was 1m thick and exposed to a depth of 0.6m before excavation ceased. The top of the wall was 1.1m below ground level; lower than the top of wall [05]. It appeared to be fair faced on its southern side, composed of sandstone blocks bound by the same mortar as wall [05]. The wall was rubble cored. Occasional inclusions in the bonding matrix were animal bone fragments, oyster shell and small sub- rounded pebbles. There was no apparent foundation cut for wall [07]; it was overlain and abutted by deposit [06], a sample of which contained post- medieval building remains (see Appendix 2).

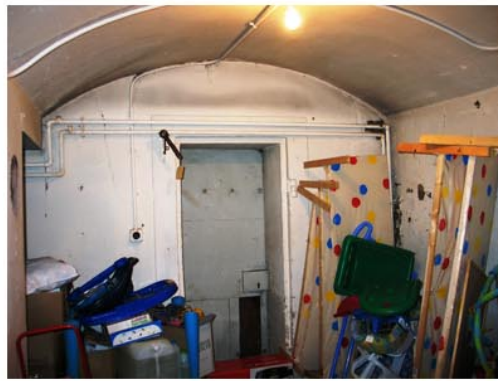
BHL07-24.jpg

The vaulted room (Plate 24) in the lower ground floor of the former County Halls is either original or post-1850s. It was either constructed as a boiler room, or as a secure chamber. The W doorway is probably later and the rooms here are subdivided by Period 4 partitions. The E window (although barred) may also be later, though it is still Period 3. The finishing in the vaulted room is from Period 4.
